# Singapore parties dispute blame for "Nicoll" collapse

The public inquiry into the Nicoll Highway disaster has identified how the tunnel failed. Now everyone awaits the judge's decision on who was to blame. Andrew Mylius reports.

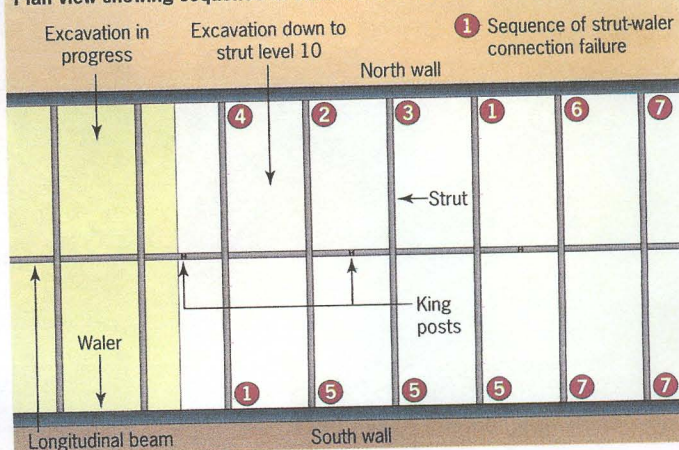
Plan view showing sequence of strut-waler connection failure

But before the final level of struts could be installed, the level nine struts became overloaded and their connections with the waler beams yielded. This allowed the walls to deform, in turn causing overloading

of struts above. This triggered progressive collapse of the walls.
