PRELIMINARY REPORT

ON THE L'AQUILA $M_w=6.2$ ($M_L=5.8$) EARTHQUAKE (6TH OF APRIL 2009),
ABRUZZO, CENTRAL APENNINES, ITALY

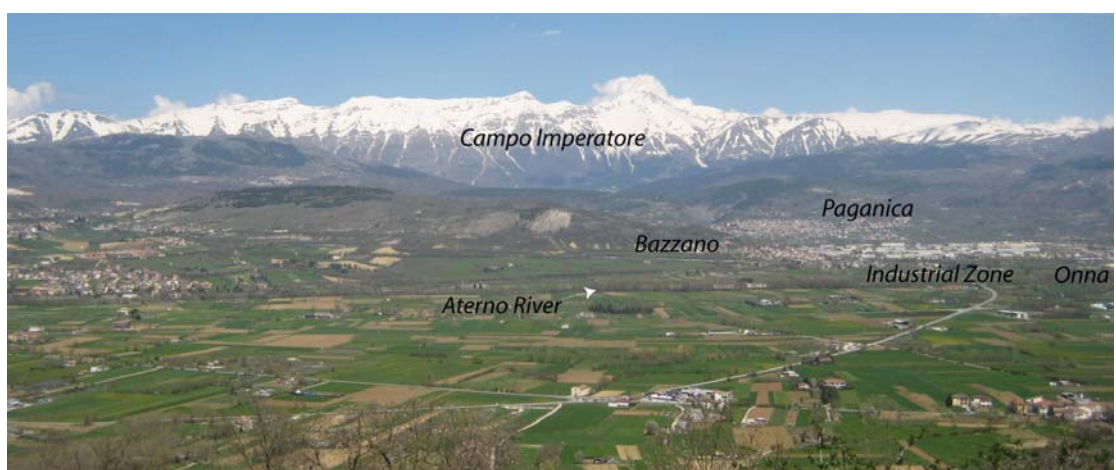
Figure 2

Figure 2. View of the Aterno Valley and the Campo Imperatore.

The highest damages were recorded in the Aterno valley (Figure 2) that is bounded northwards by the L' Aquila fault. The L' Aquila fault is a 37 km long structure that strikes northwest-southeast and downthrows to the southwest (Roberts and Michetti 2004). Its southern tip is located near Civitaretenga village (2 km east of Caporciano) and its northern tip is located towards the western end of Mt. San Franco (Figure 3, Figure 4). This fault has a rather complex structure, since it comprises several overlapping segments some of which are antithetic to the main SW dipping (Figure 5a) fault plane (Papanikolaou et al. 2005). These antithetic planes are nicely observed northwards the village of Barisciano (Figure 5b and 5c), have fresh looking fault planes and maybe linked to the possible active NE dipping fault in the southern part of the valley. In a few words the strain in the area is accommodated on multiple closely spaced synthetic and antithetic overlapping segments. Therefore, the fault zone is characterised by distributed displacement on several overlapping faults that break up the footwall and the hanging wall into smaller blocks. The latter implies that searches for potential primary surface ruptures should extend over a large area. This fault has a reported throw-rate of 0.3-0.4 mm/yr (Galadini and Galli, 2000) based on offset Quaternary terraces (Bertini and Bosi, 1993) and up to 1.1mm/yr towards its centre that decreases to 0.7mm/yr near Mt. Franco and 0.3mm/yr towards Caporciano, based on the throws of the postglacial scarps (Papanikolaou et al. 2005). Many Pleistocene palaeolandslides of tectonic origin are reported for this fault concealing the position of the fault trace close to the valley (Demangeot, 1965; Bagnaia et al., 1992).

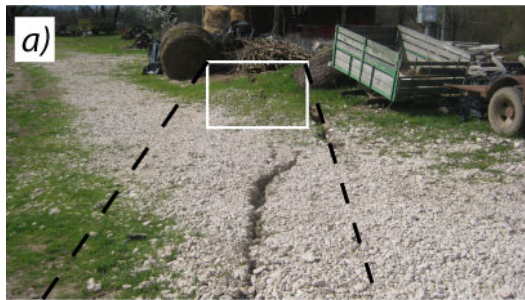
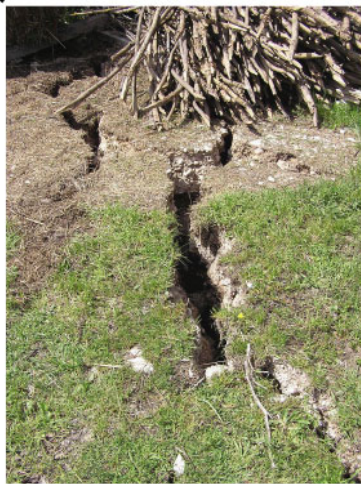
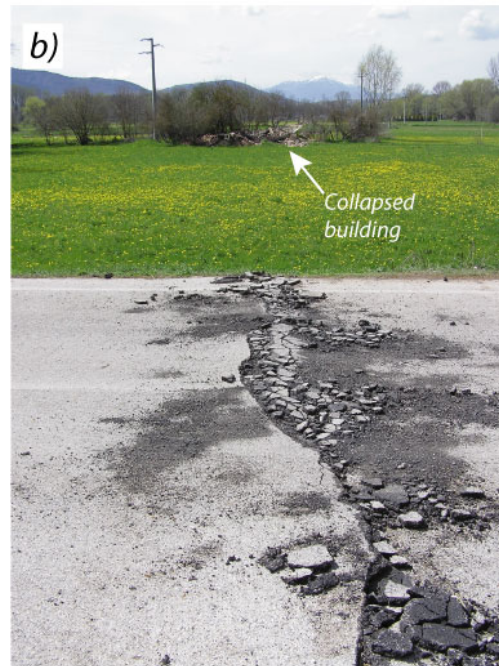
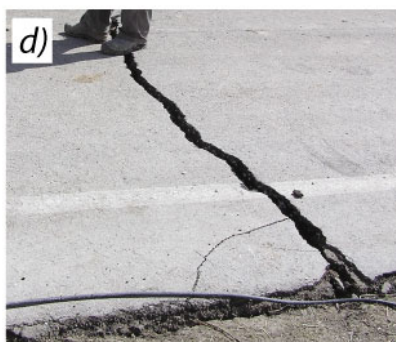
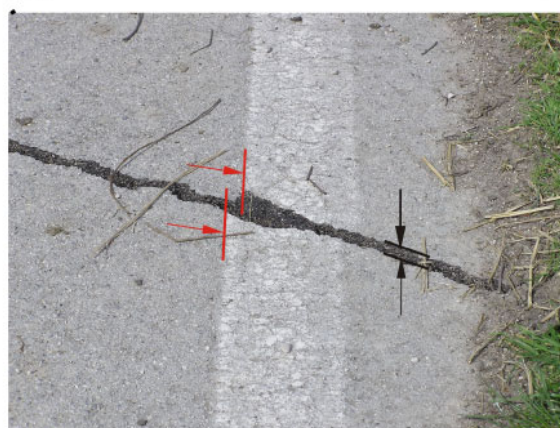
Figure 6

Figure 6. View of the secondary ruptures near the village of Onna. All secondary ruptures are NW-SE ($150^\circ \pm 20^\circ$) trending parallel to the activated fault plane and the existing active faults and appear in artificial and natural structures that are prone to rupturing. a) Secondary ruptures several tens of meters long and up to 30cm wide, near the river embankments. b),c),d) transverse ruptures in paved roads that are several meters long and having offsets of several cm (up to 6cm) both horizontal and vertical. Local people reported to us that some of these ruptures were formed and some others were extended following the first large aftershock ($M_w=5.6$) that occurred on the 8th of April.

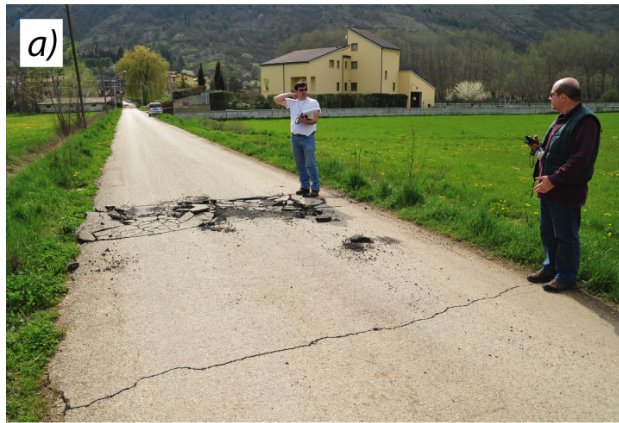
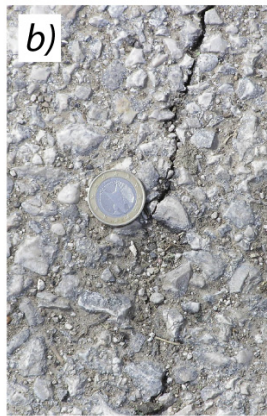
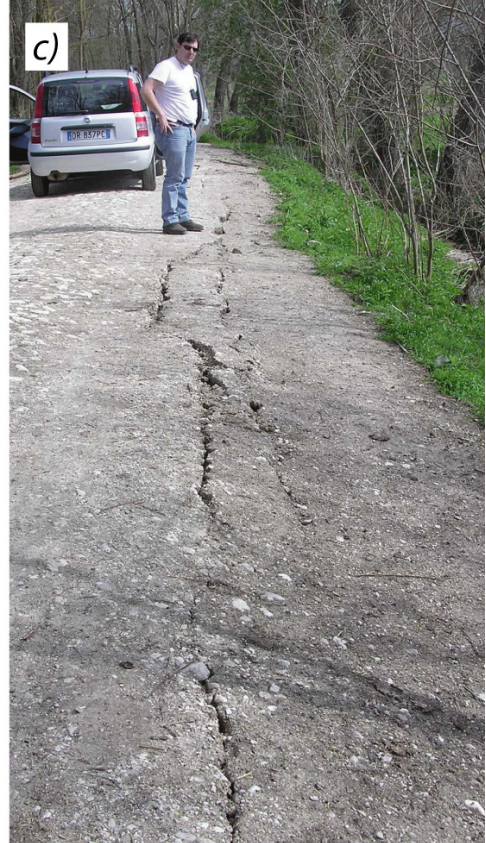
Figure 7

Figure 7. View of the secondary ruptures between the villages of Onna and Fossa. a) Ruptures on paved road. b) The cracks were violent so that they ruptured also the asphalt pebbles. c) NW-SE trending ruptures in a non-paved road that links the village of Onna with the village of Fossa.

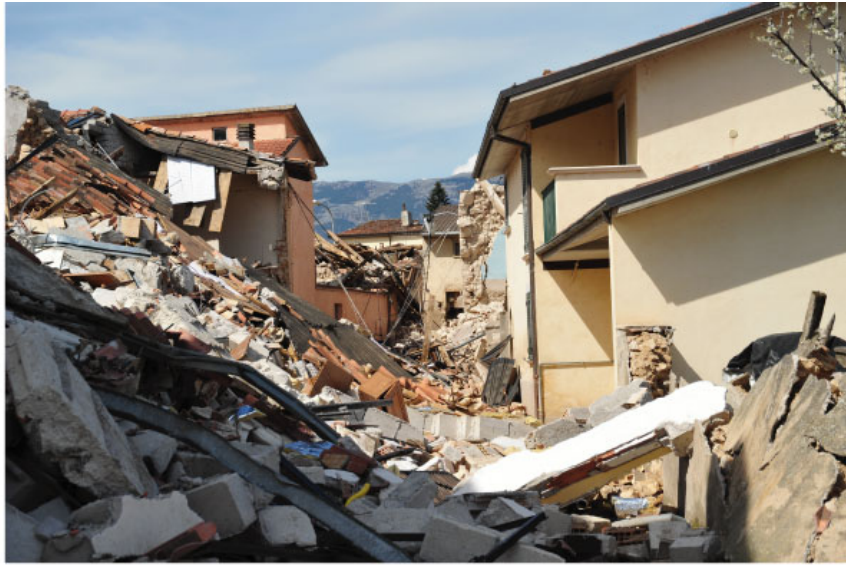
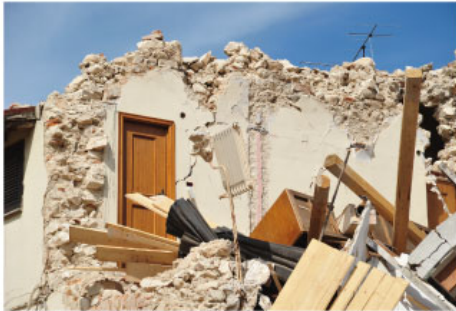
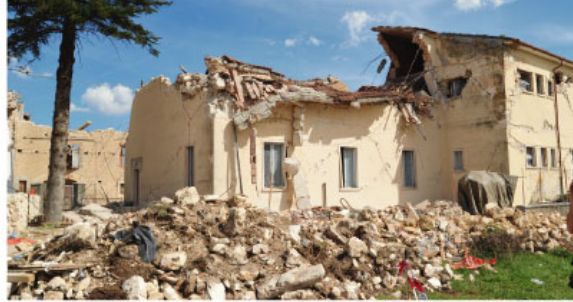
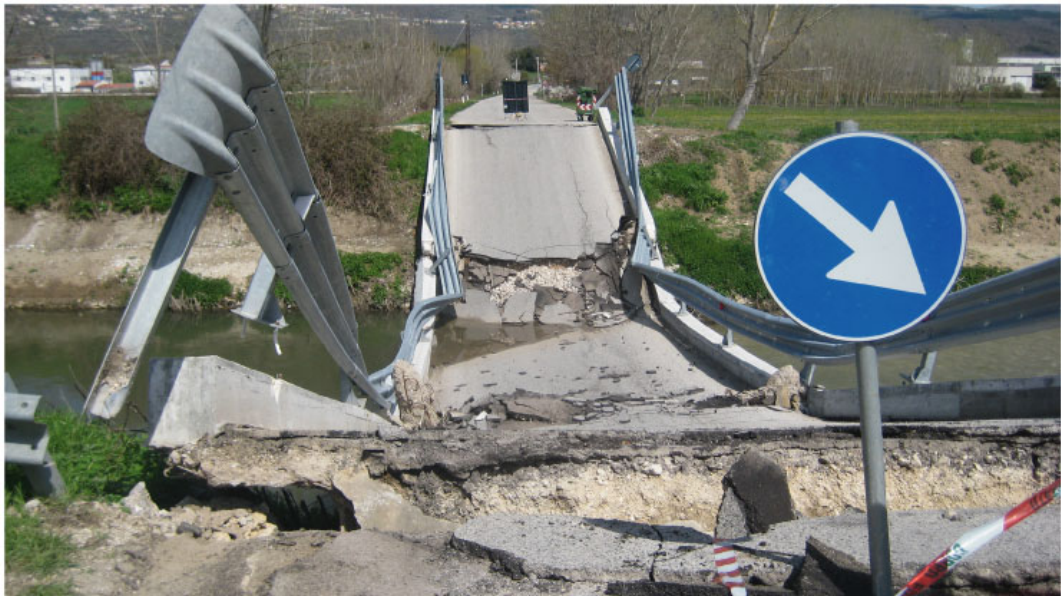
Figure 8

Figure 8. a) View of the extended damages and collapses towards the village of Onna. b) Collapsed bridge about 1km southwest from the village of Onna.

The majority of the damages in these villages relate to old masonry buildings (Figure 8). However, in the town of L' Aquila several modern buildings collapsed or sustained severe damages (Figure 9), implying that the construction quality is not the only cause for such damages. Several modern multi-store buildings are characterized by crumbling masonry and collapsed fill walls. This is systematically observed towards the ground and first floor of these buildings, which probably experienced higher stresses than the higher floors. The L' Aquila sedimentary basin is characterised by unfavourable site specific conditions. The basin is filled with a few hundred meters of lacustrine sediments that overlie the bedrock (Blumetti et al. 2002), producing significant ground motion amplification effect at low frequencies (De Luca et al. 2005). This amplification is mostly attributed to the couple of hundred meters thick lacustrine sediments. This may also explain the discrepancy between the higher damages compared to the relatively low environmental effects that have been recorded. The latter should be considered by the local authorities for the future planning, because the faults in the area have the capacity to generate stronger than the recent $M_w=6.2$ event, which partly relieved the stress in some of the fault segments.

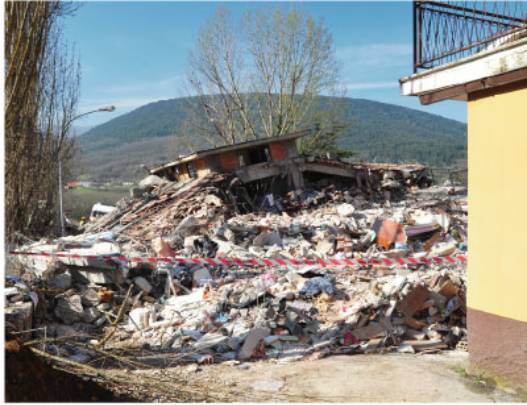
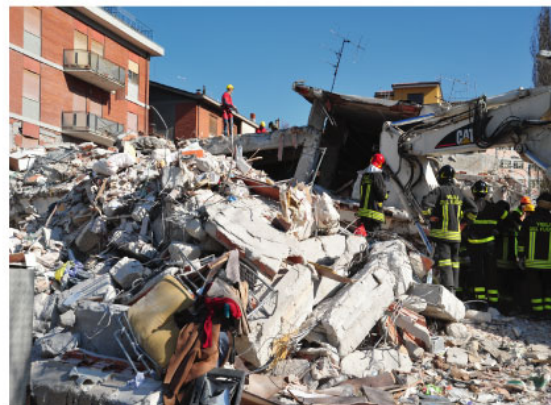
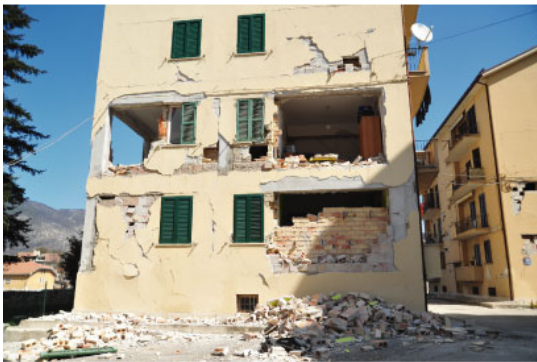
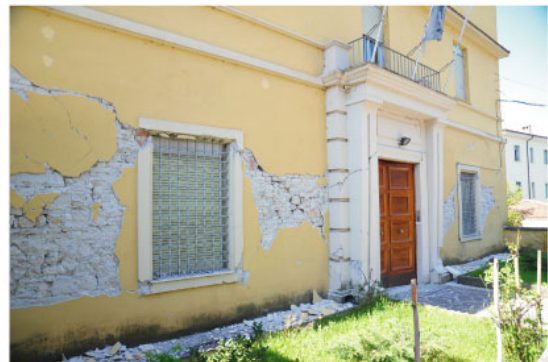
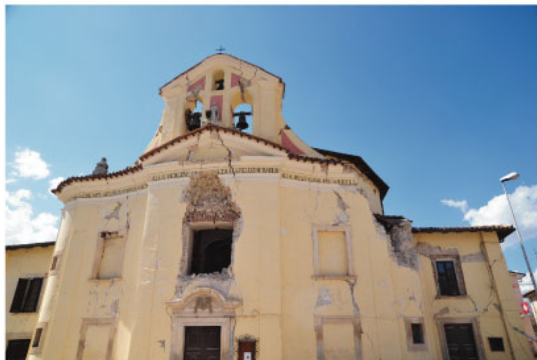
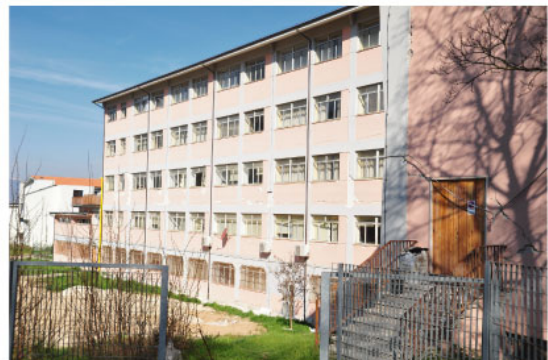
Figure 9

Figure 9. View of the damages in the town of L' Aquila. Damages and collapses were inflicted not only in old masonry buildings, but in several modern buildings as well. Several modern multi-store buildings are characterized by crumbling masonry and collapsed fill walls. This is particularly observed towards the ground and first floor of these buildings, which probably experienced higher stresses than the higher floors. Finally, several public buildings such as schools and municipality buildings suffered significant damage.
