# Singapore parties dispute blame for "Nicoll" collapse

The public inquiry into the Nicoll Highway disaster has identified how the tunnel failed. Now everyone awaits the judge's decision on who was to blame. Andrew Mylius reports.

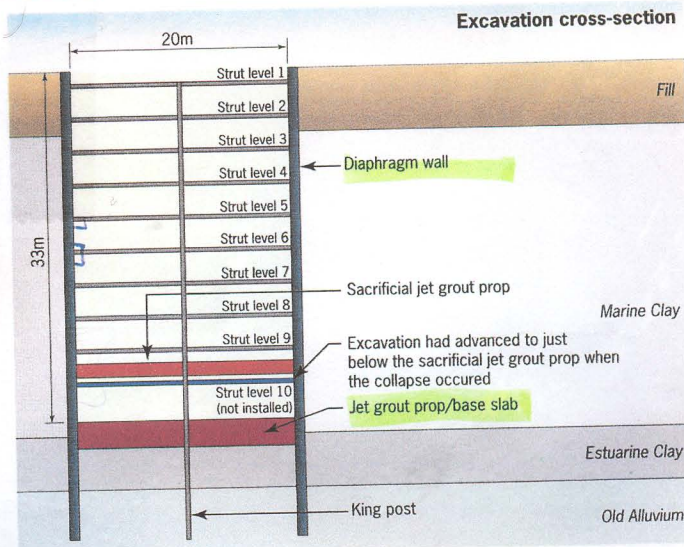
Plan view showing sequence of strut-waler connection failure

But before the final level of struts could be installed, the level nine struts became overloaded and their connections with the waler beams yielded. This allowed the walls to deform, in turn causing overloading

Failure was rapid. Only an hour elapsed between failure of the first strut-waler connection and total collapse of the excavation.
